# A CONSULTANT STUDY for

NORTH LAWRENCE COMMUNITY SCHOOLS

Bedford, Indiana

August 1980

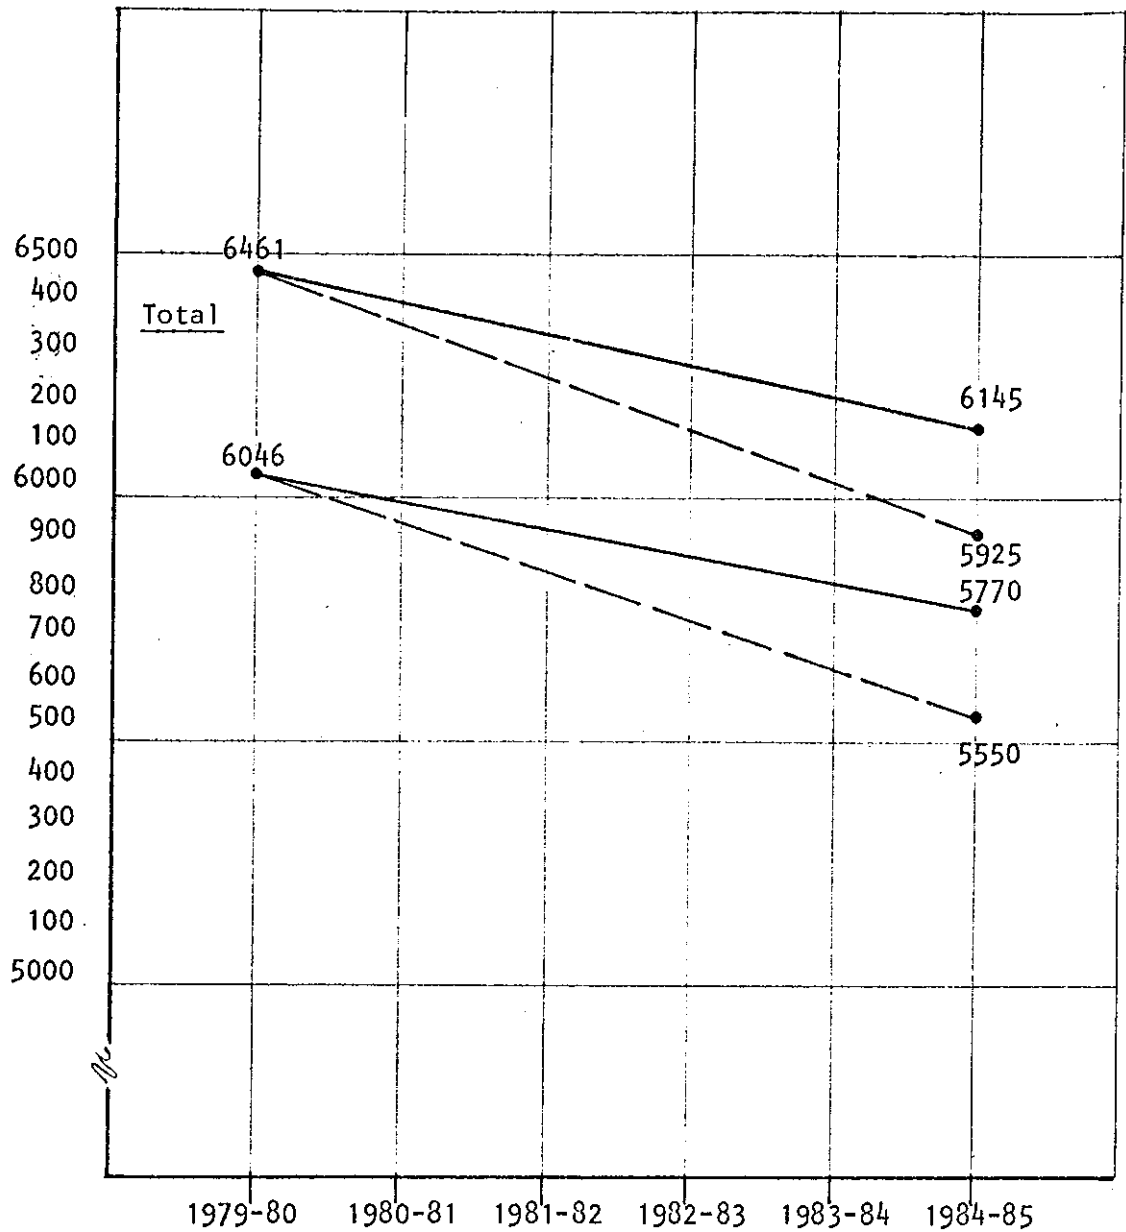
Chart 1. Projected range for K-12 and to  
Enrollments, 1980-81 through 1984-85

From these estimates, an enrollment range becomes evident. Chart 1 indicates a range for the total enrollment (K-12 plus special education and vocational education) and the K-12 enrollment. In reality, the year to year totals will not be equivalent, but for purposes of these projections, the focus is on the total enrollments projected five years hence.

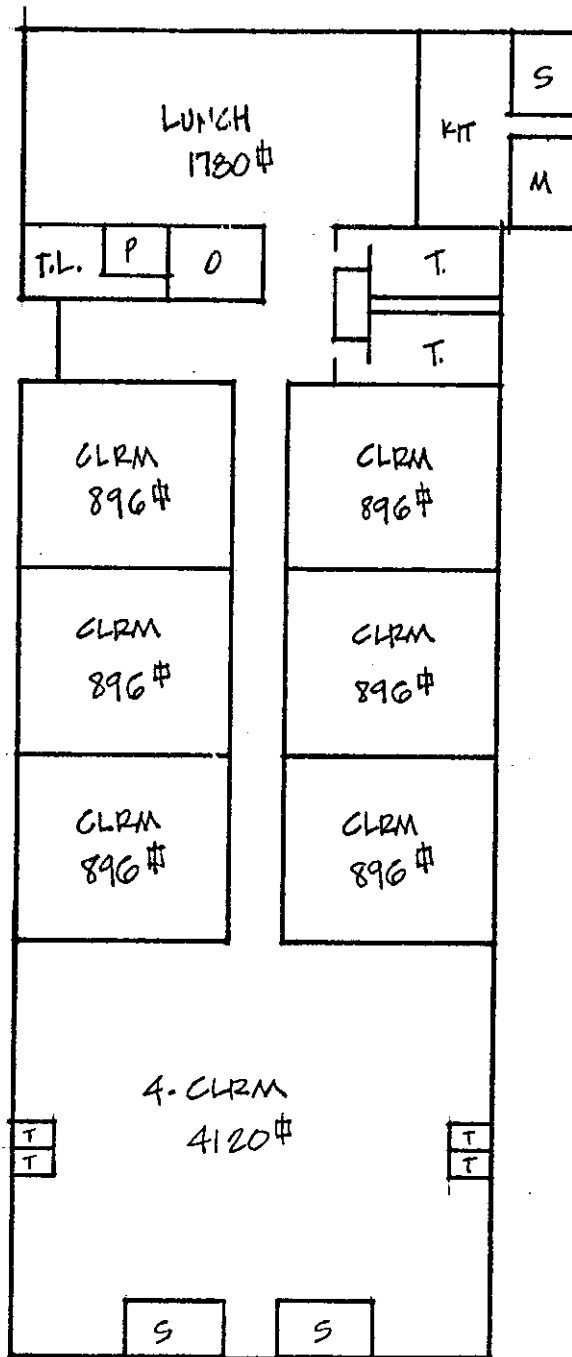
SPRINGVILLE ELEMENTARY  
SCALE: 1"=30'

- Stone masonry walls in good condition. East side concrete block with painted surface in fair condition.
- Aluminum window frames with single-pane glazing. Some insulated panel replacement of glass started.
- Wood soffits and trim with painted gutters and downspouts.
- Hollow metal entry doors and frames. Sidelights not protected by horizontal mullions.
- Step at entry violates current handicapped code.
- Flat built-up roof with minimum insulation.
- Playground asphalt areas in fair condition.
- No provisions for handicapped parking or building access.

- Electric unit heaters and window air conditioners are used in the original building. Combination heating/air conditioners are used in the open plan addition.

- A roof top air conditioner serves the administrative area.
- City water serves the building and a septic system handles waste water.
- Kitchen area is not fire separated from multi-purpose area.

- Hollow metal doors throughout are not rated and corridors do not meet fire separation requirements.
- Toilet rooms are in fair condition. No provision for handicapped toilets or drinking fountains.

There are some additional areas that are needed to make this a complete elementary building.

1. Need indoor physical education area.
2. Need clinic area.
3. Need larger area for library.
4. Space for art and music is less than current requirements.
5. Need additional storage facilities.

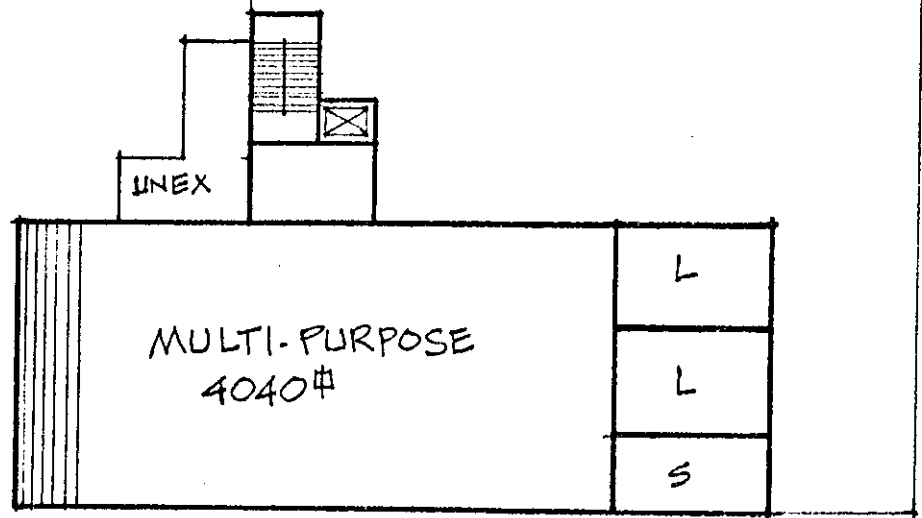
INTERMEDIATE LEVEL  
DOLLENS ELEMENTARY

- Limestone masonry walls in good condition.
- Aluminum window frames with single-pane glazing. Some window wall areas have glass block above horizontal aluminum frame runs.
- Hollow metal entry frames rusting and need replacement.
- Built-up roof is flat with ponding water problems, minimum insulation and exterior downspouts.
- Asphalt playground in fair condition.
- Building entry is low and storm water runs into building.
- An elaborate concrete ramp system has been constructed to provide pedestrian traffic access across the highway.

- Plaster ceilings are attached to bottom chord of bar joist throughout. Acoustic tile is glued direct to plaster in corridor areas. Some areas have suspended acoustic tile ceilings where original plaster was damaged by roof water leaks.

- Non-rated wood doors in metal frames do not provide the code required corridor/classroom fire separation.
- A gas boiler with circulating hot water provides heating and window air conditioners serve to cool the classrooms.

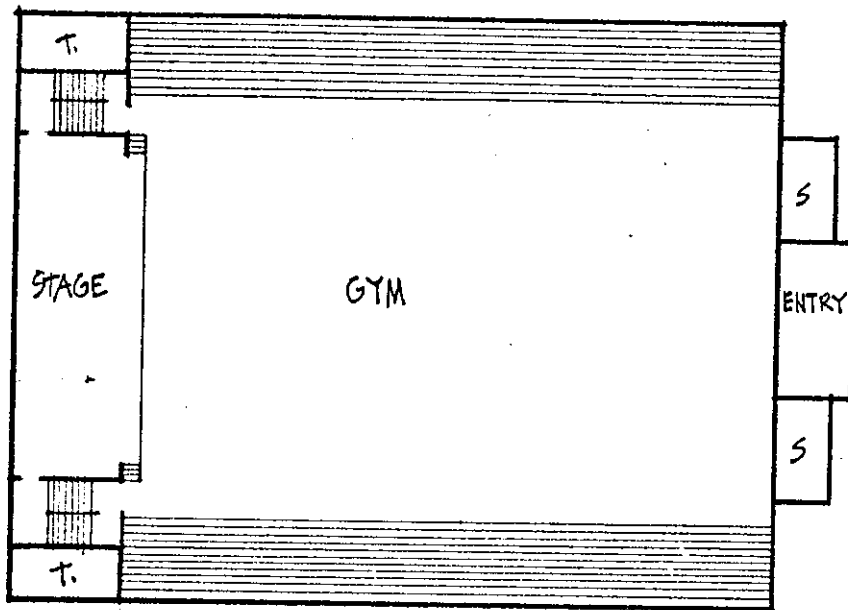
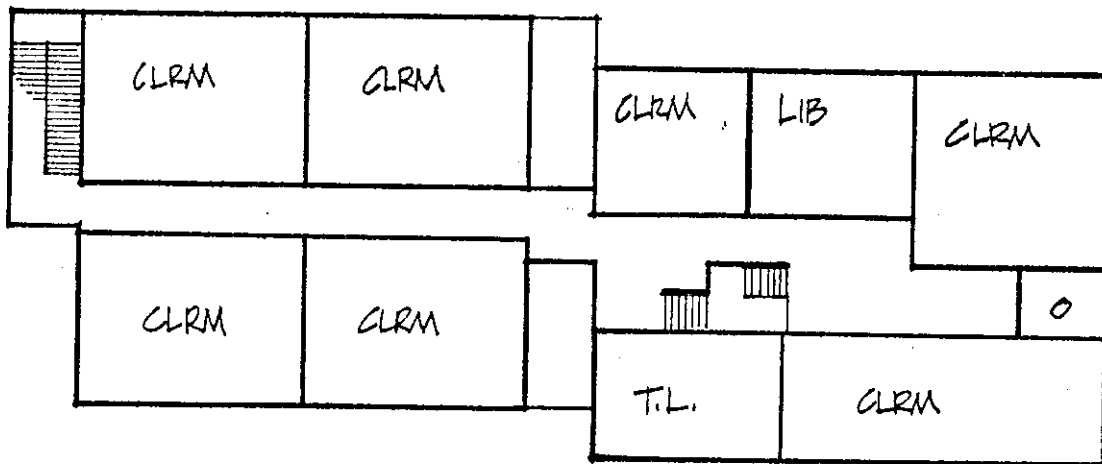
TUNNELTON ELEMENTARY

There are many deficiencies, especially within the original building.

1. All of the instructional areas are less than Rule B requirements with the exception of the gymnasium.
2. Programs and buildings are not accessible to the handicapped.
3. Programs such as music, art, library, speech and hearing, kindergarten and special education are really hampered by inadequate space.
4. See general building appraisal for severe code violations in building structure.

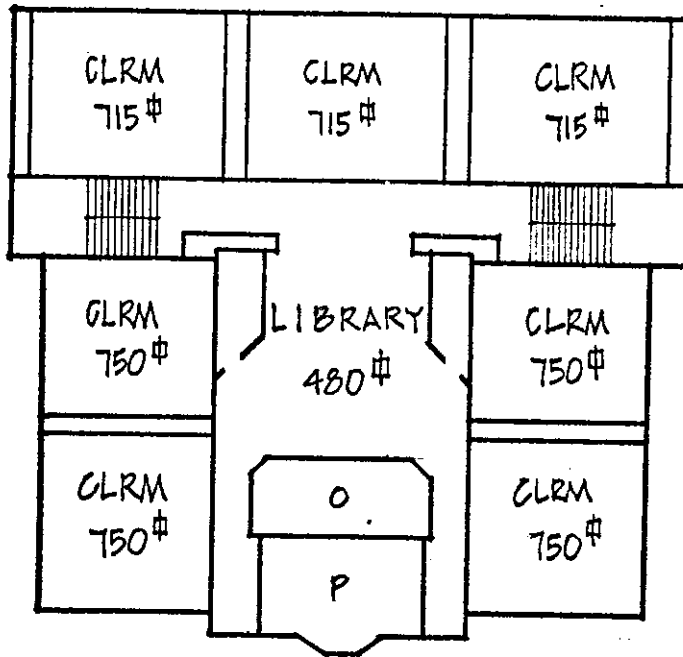
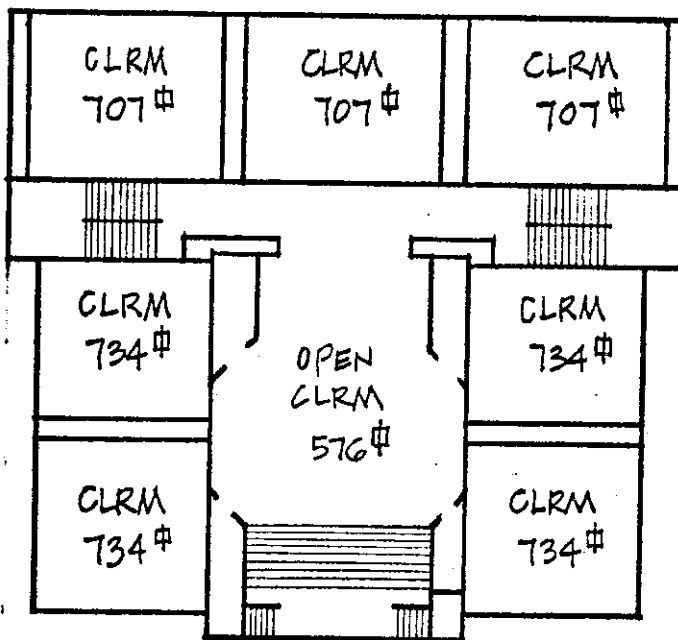
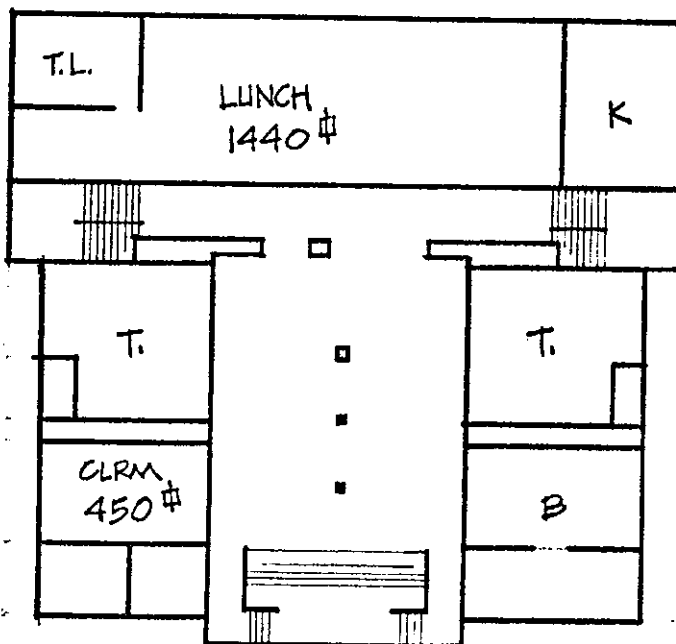
STALKER ELEMENTARY

The facility has recently undergone some renovation to upgrade the overall appearance and efficiency of the building. There are still deficiencies within the building that can and may hamper the educational program.

1. Tri-level with classes located below and above grade.
2. All of the instructional areas are below standard size.
3. No indoor physical education area.
4. Building does not have restrooms on all levels.
5. Programs and building are not accessible to the handicapped.
6. See general building appraisal for other code deficiencies.
